Burts Miller Ranch

The Burts Miller Ranch snow course is located on the main-stem of the Bear River, about ¼ mile off of highway 150 on the east side and just south of the Burts Miller Ranch headquarters and barns/corrals. The site is at an elevation of 7900 feet msl. Potential weather modification: 77, 89-93, 95, 01-

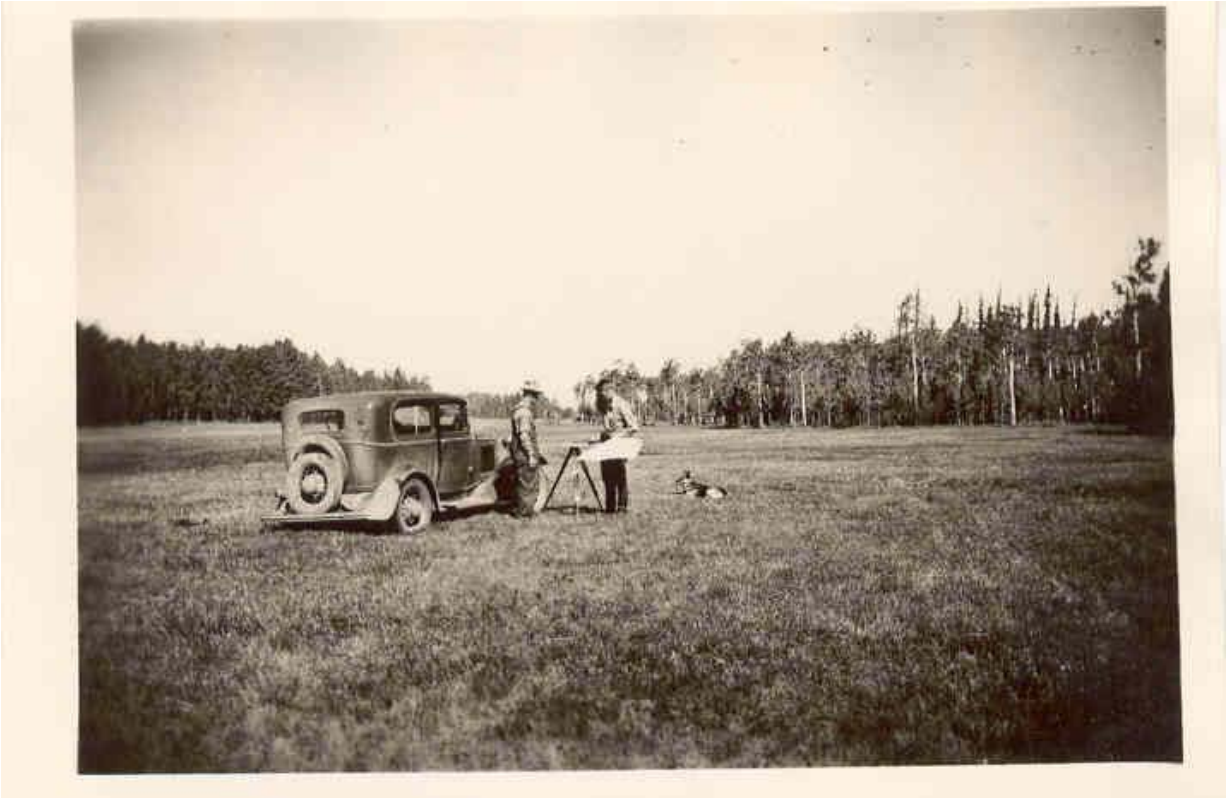
The following 1936 photos show the open meadow that the snow course is located in. It runs down the meadow from right to left, just past the car in the first photo. Notice how flat the meadow is and the height and location of the aspens. The vegetation has not had significant changes between the time of this photo and the current condition in 2007.

Looking north along the main axis of the course.

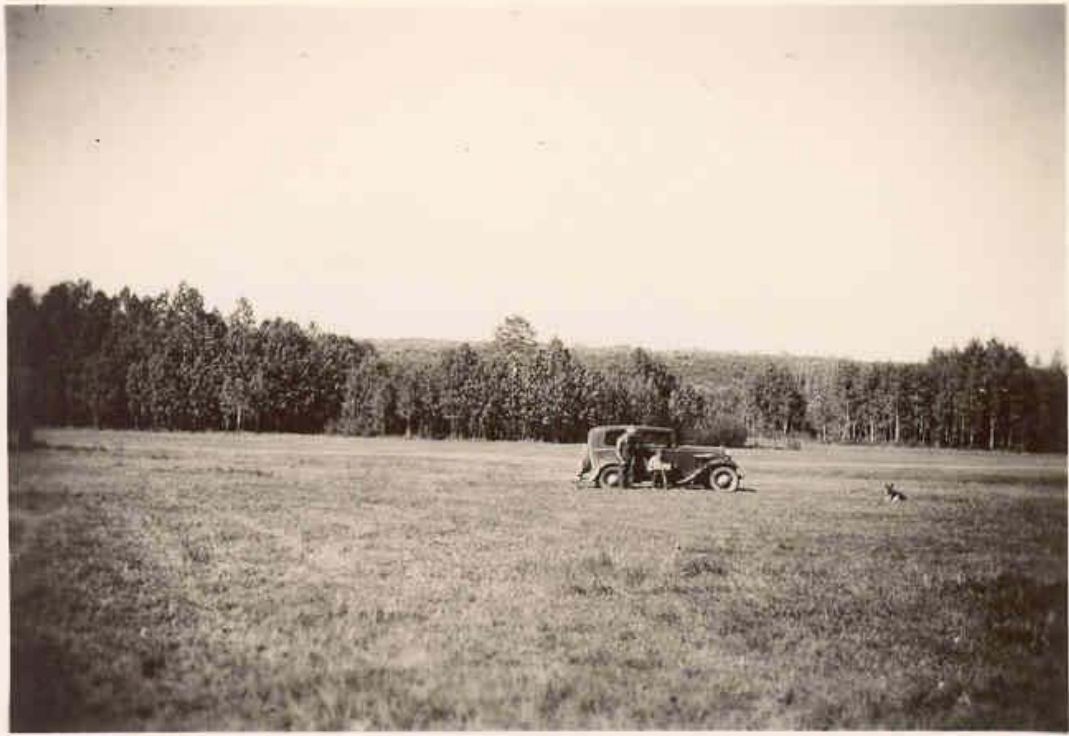
Looking east perpendicular to the course.

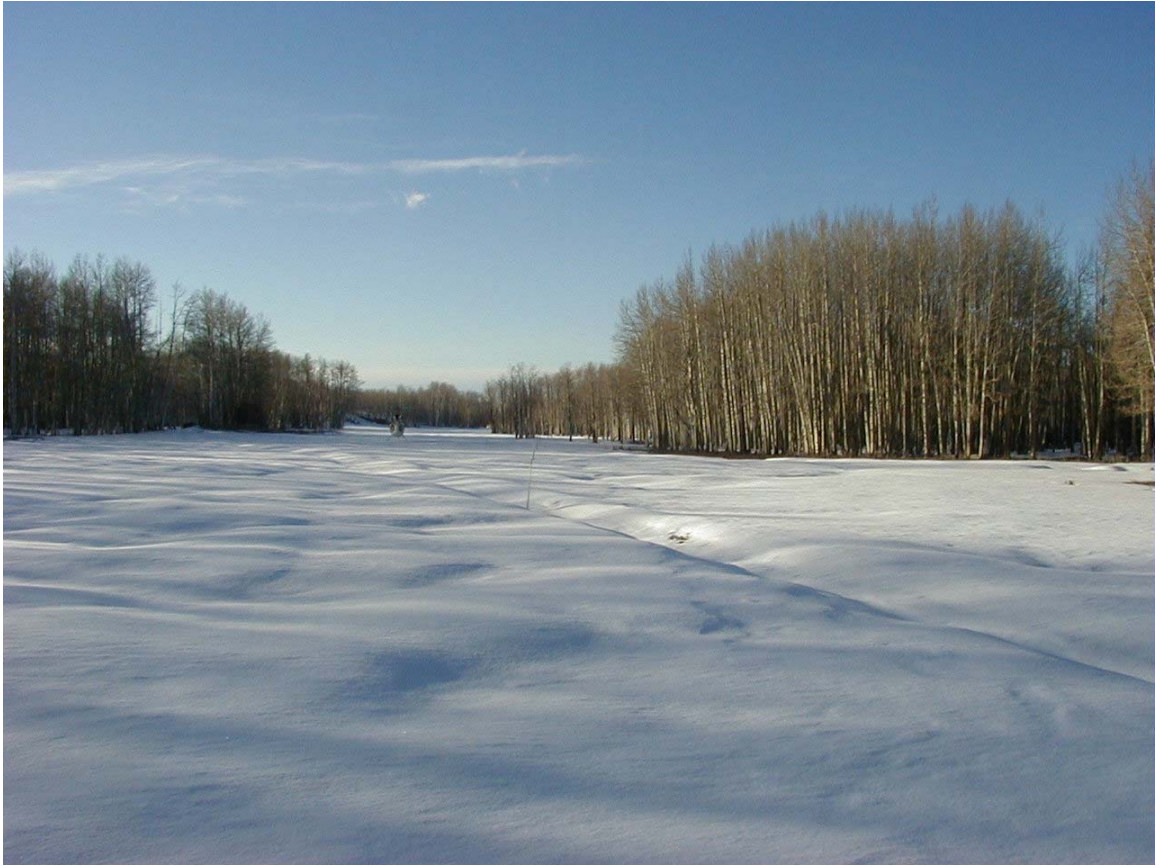
In this recent photo the ditch along the snow course as well as the mottled/dimpled snow surface indicative of uneven melting patterns are visible. The ditch is actually a cattle trail down the meadow and along several of the sample points. It seems as though the cattle use the marker poles as a scratching post at times, as the area around the poles can be trampled as well.

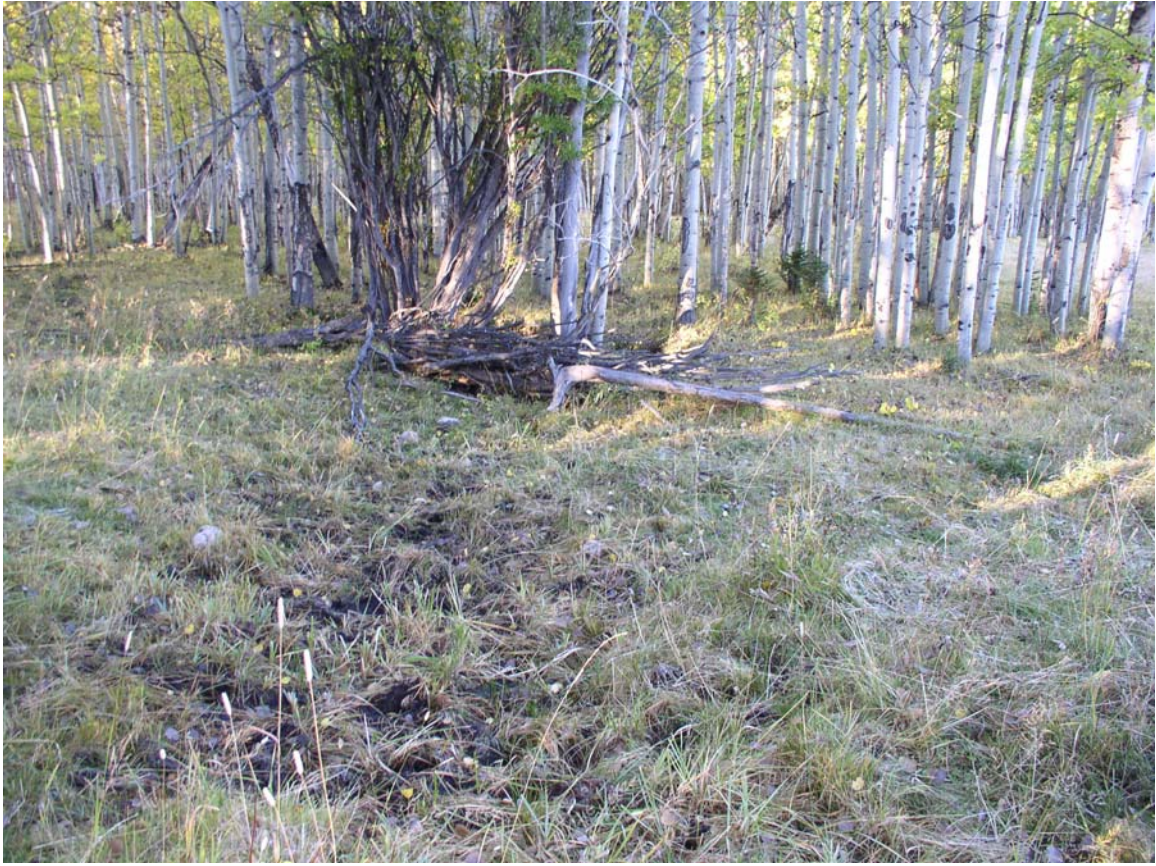
This photo taken at the south end of the snow course shows the cattle crossing at a small ephemeral stream at the head of the meadow.

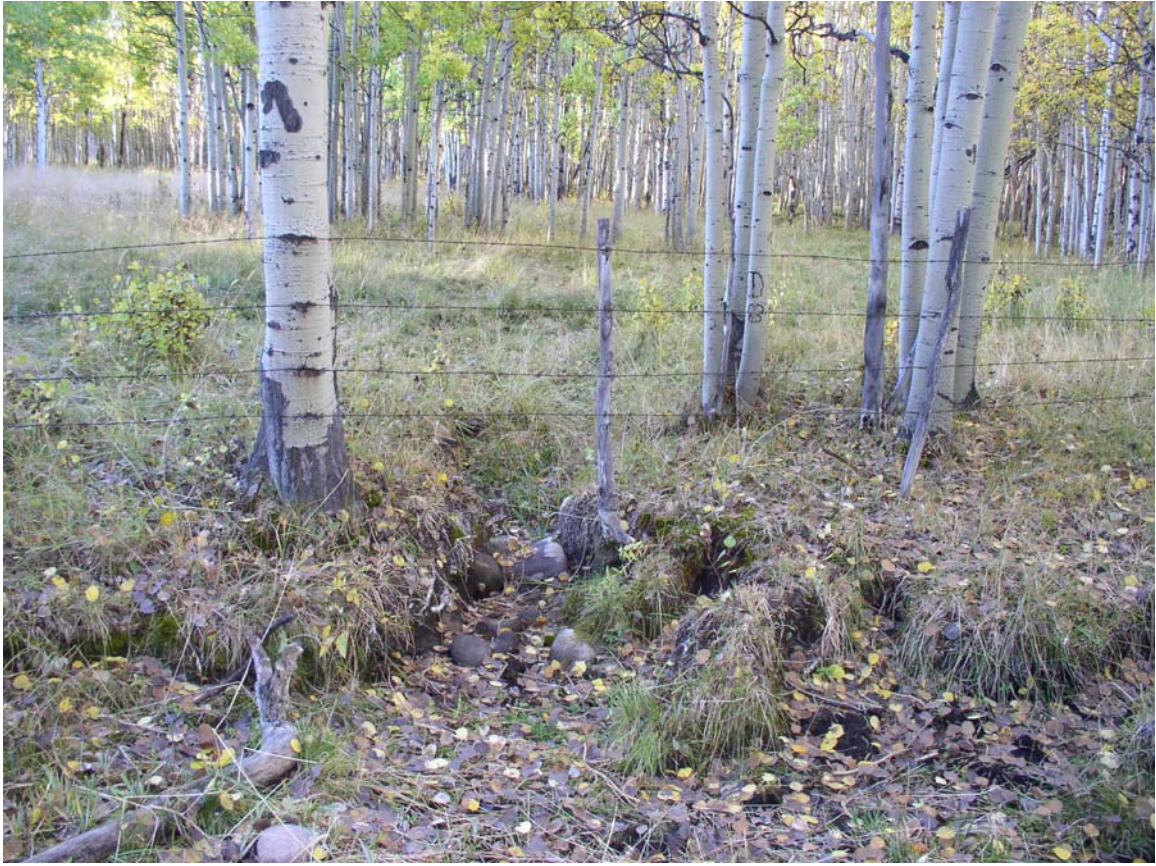
The stream a little higher up from the south end of the course and shows clear evidence of overland flow with erosional features.

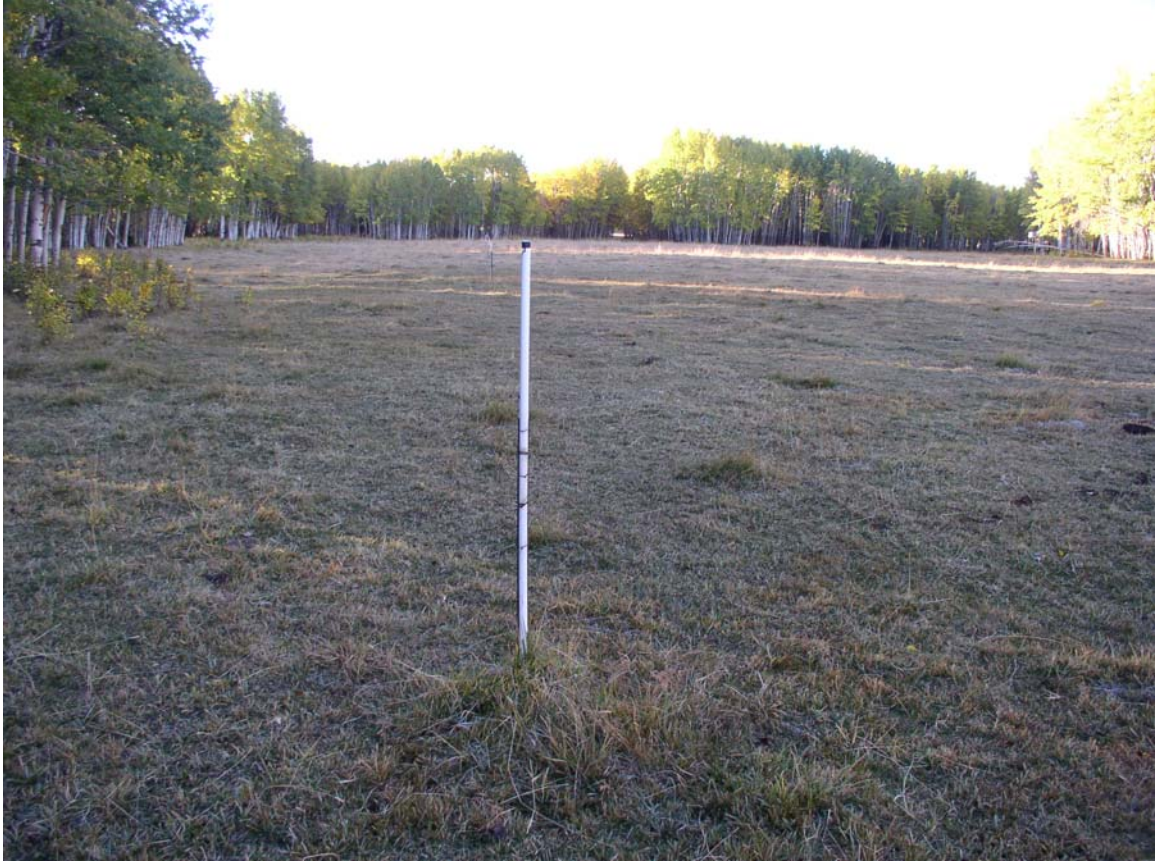
The course looking from north to south. The trees have slightly encroached into the meadow but not in a way that we think would substantially impact the accumulation or ablation characteristics.

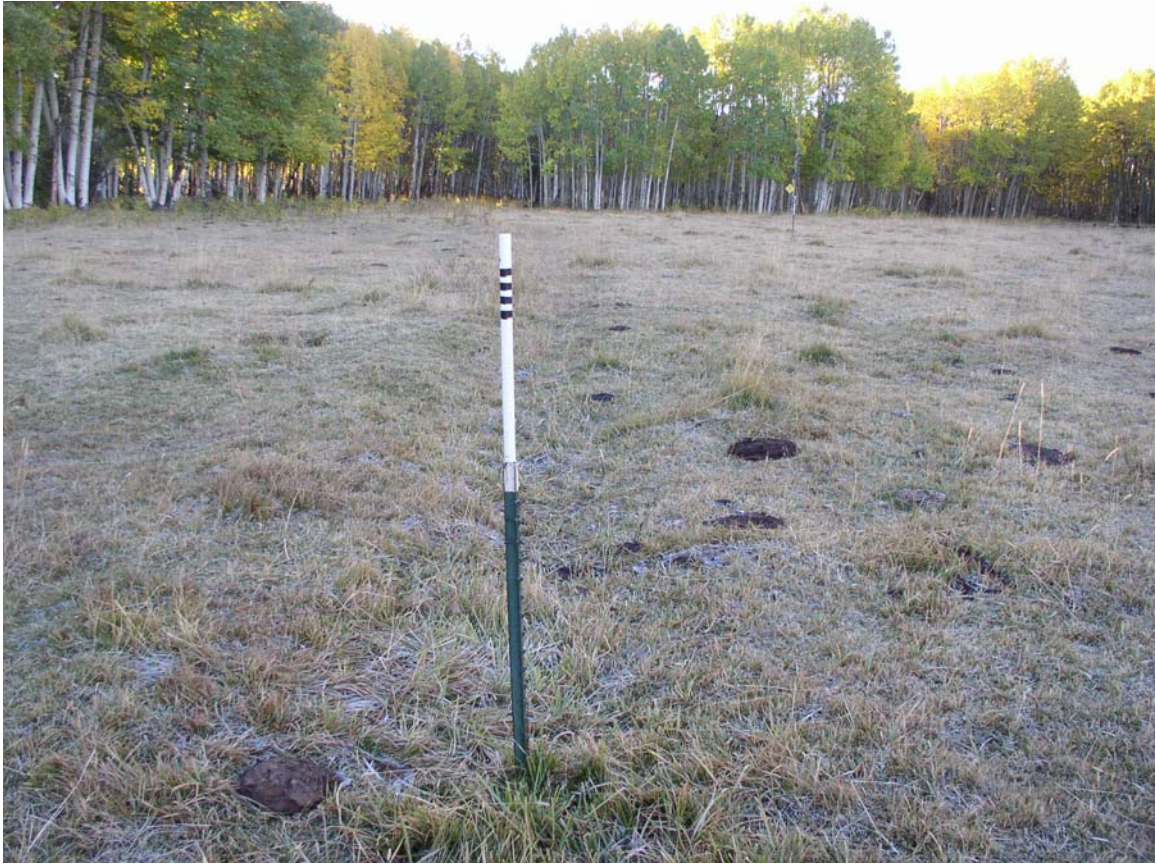
This photos shows the slight change in topography caused by the cattle. The sample marker is directly in the cattle trail/ditch. The impact to snow accumulation is, however, much more dramatic as noted in previous photographs.

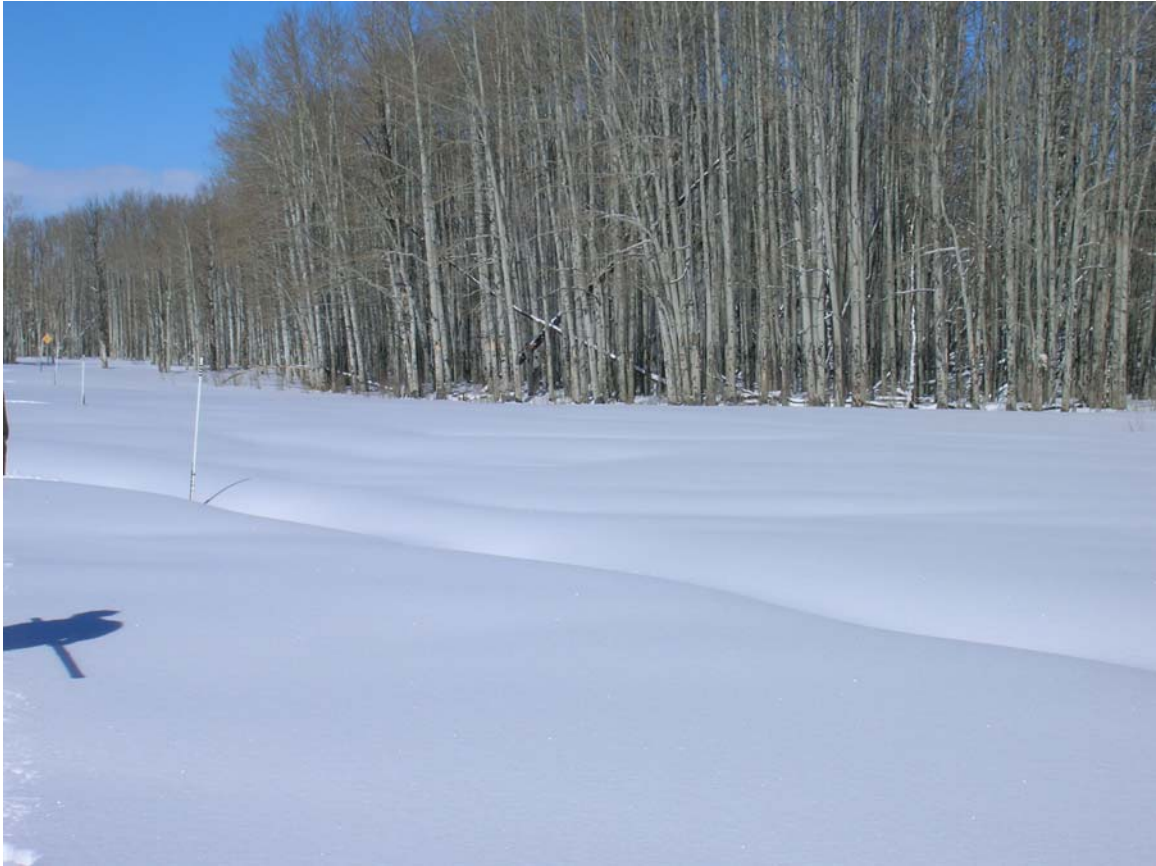
From that small change in topography and likely from the impacts of sub-irrigation, note the dramatic change in snow accumulation along that path in this photo from the March 2007 survey. Also notice the same mottled look with dimples in what should be a pretty homogenous snowpack across a flat meadow.

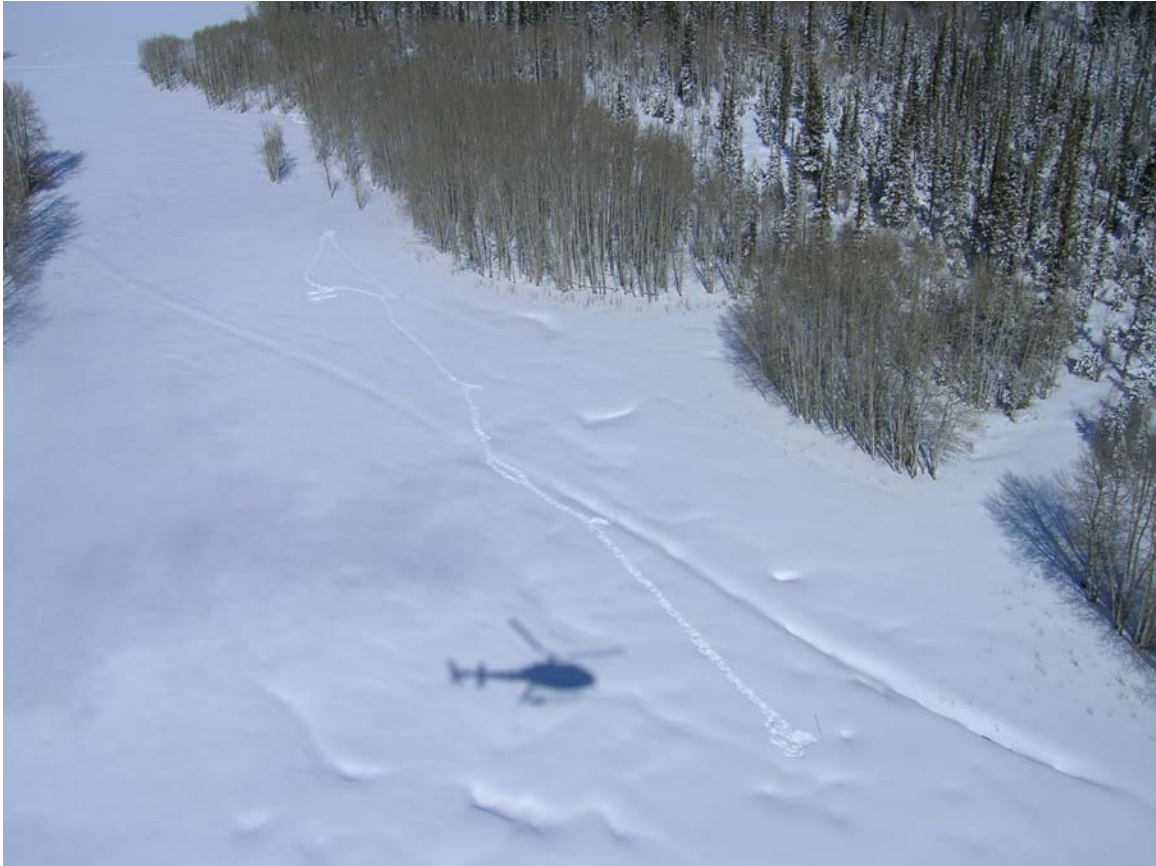
This photo taken on the same March 2007 survey, clearly displays the impacts of what appears to be water features in the meadow as well as the cattle trail. The impacts on accumulation are evident in the features however, what is not precisely known is what the impact may be on the entire meadow. If the area has changed in subsurface water characteristics from the ponds, irrigation ditches, springs, beaver dams, etc that may impact the surface energy balance, then the snow accumulation/ablation characteristics may well have changed at this site as well.

Use of this snow course for long term data comparison is not recommended due to the complex nature of physical processes that may be occurring at this site. It is likely that sub irrigation from various sources is impacting both accumulation and ablation characteristics. The quantification of these impacts from others that may also be going on is indeterminate at this time and as a consequence we cannot isolate and remove that impact.

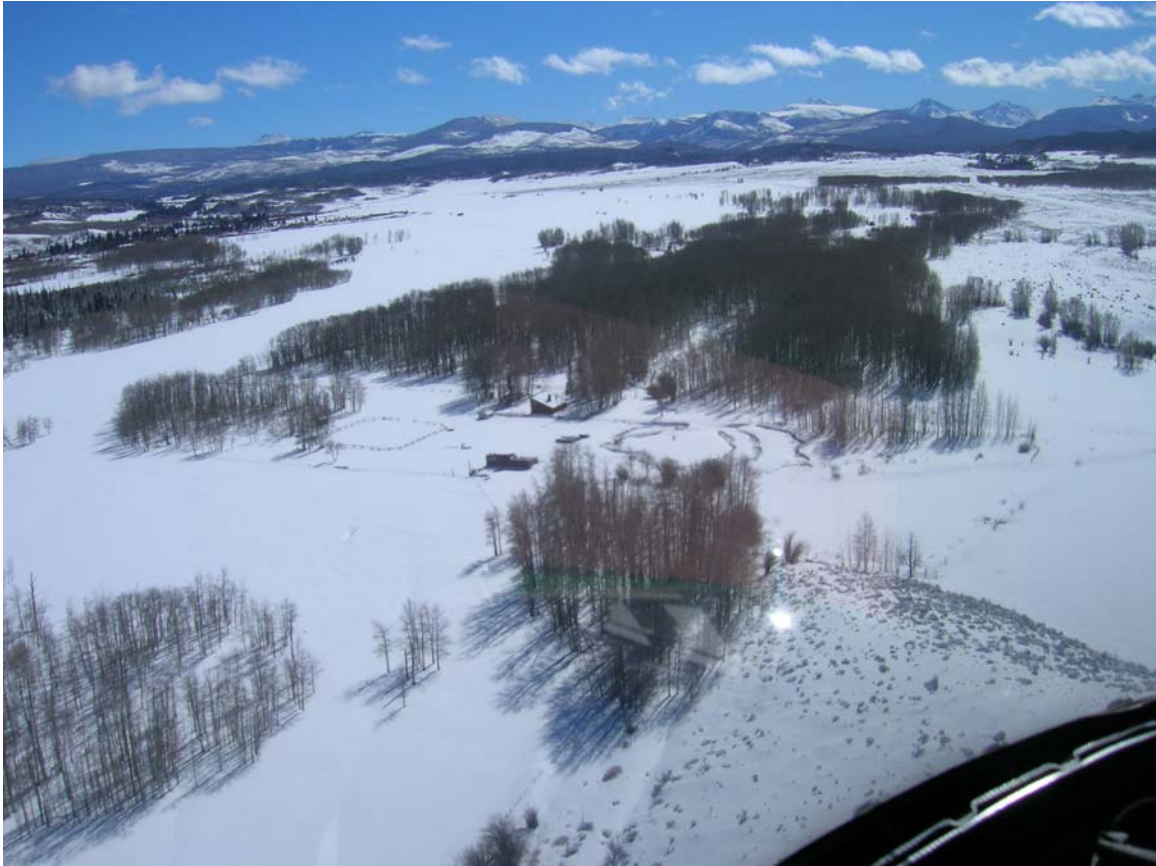
The irrigation ponds are in the center right of the photo and the ranch buildings are in the center. Mill creek is to the left side and the snow course is several hundred yards to the north, or the bottom, of this picture.

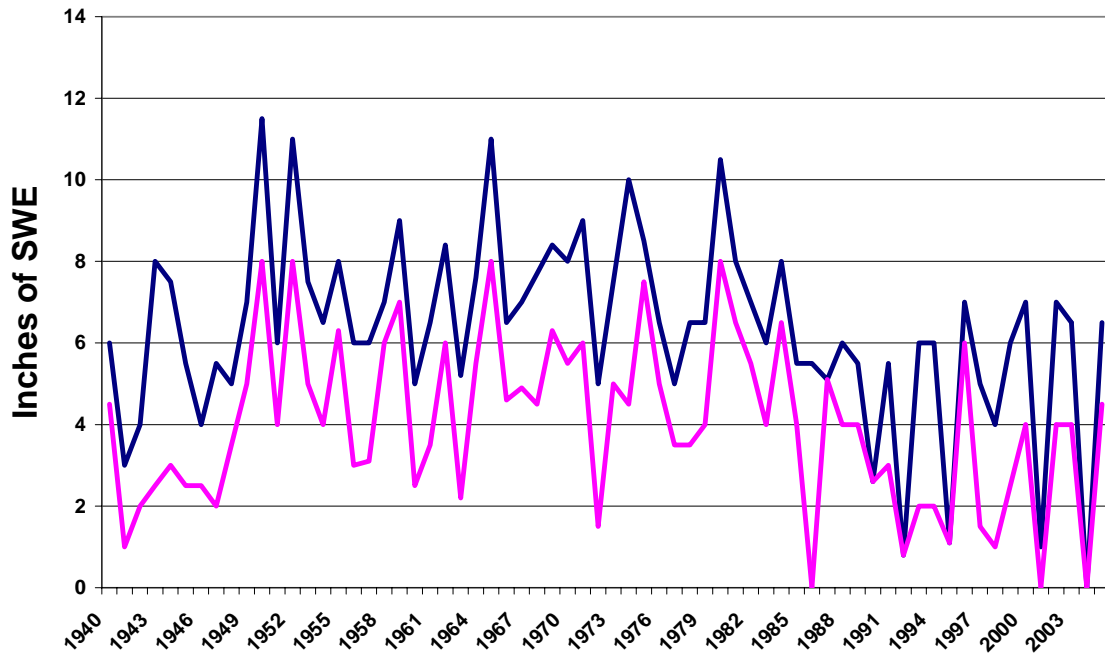
Burts Miller Ranch Sample Point SWE - Max/Min

This chart shows the max and min of the individual sample point SWE values. Note that the values fell in the early 80s and then remain relatively constant there after.

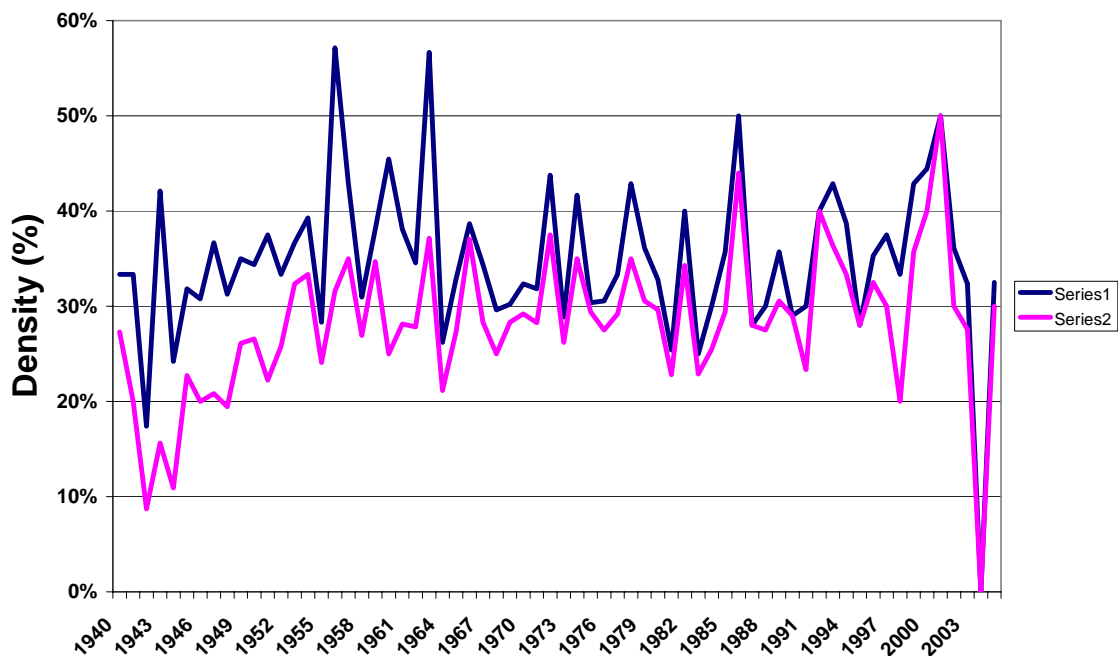
Burts Miller Ranch Sample Point Density - Max and Min

This chart shows the max and min sample point densities over time. In the early part of the record, densities were very diverse due to the fact that only one sample was taken at each point. In the late 50's and early 60's sampling was done to more rigorous technical standards and the spread of sample densities was limited to no more than 5% across all sample points, ensuring a much better overall snow course measurement. That said, it does not appear that densities have seen a much change. The one anomaly, seen in 2005 is a zero value of snow on the course, thus zero density.

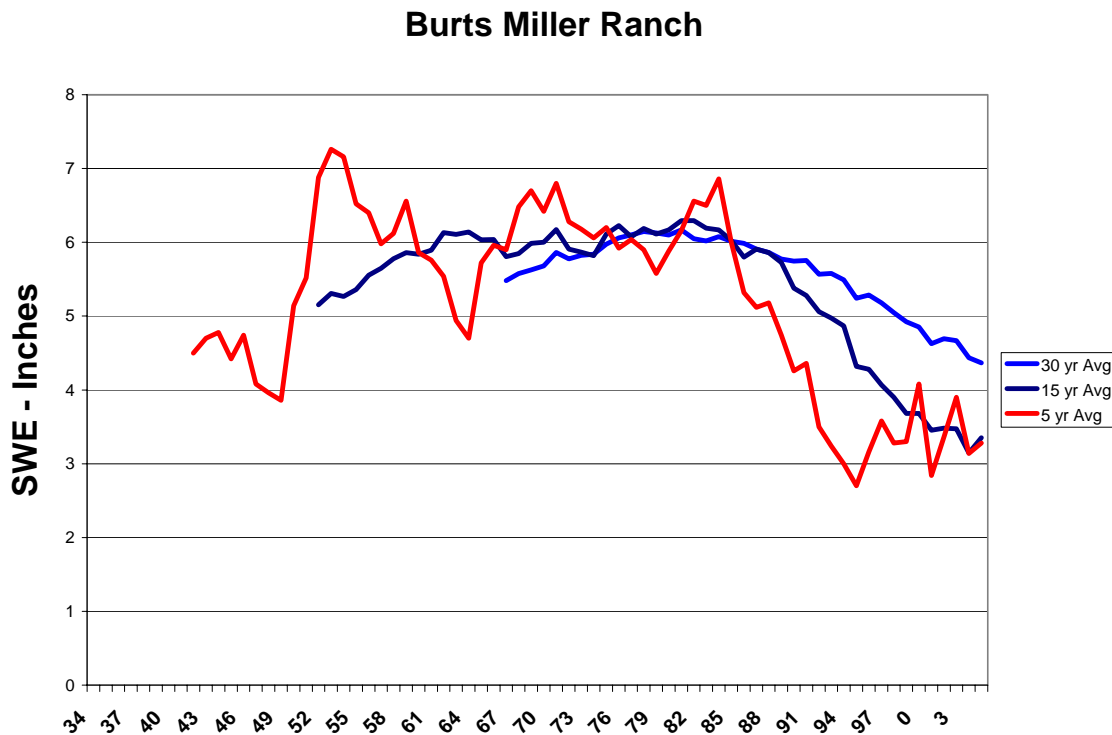
This chart shows the 5, 15 and 30 year running average SWE for April 1 values since the beginning of the course. One can clearly see a decline in SWE accumulation in the early 80s. The ditches and ponds were installed in the mid 70's.
